Maryland Historical Trust
State Historic Sites Inventory Form
Maryland Inventory of Historic Properties

Survey No. WA-I-844

Historic Name 13052 Clopper Road

City, Town Vicinity of Leitersburg

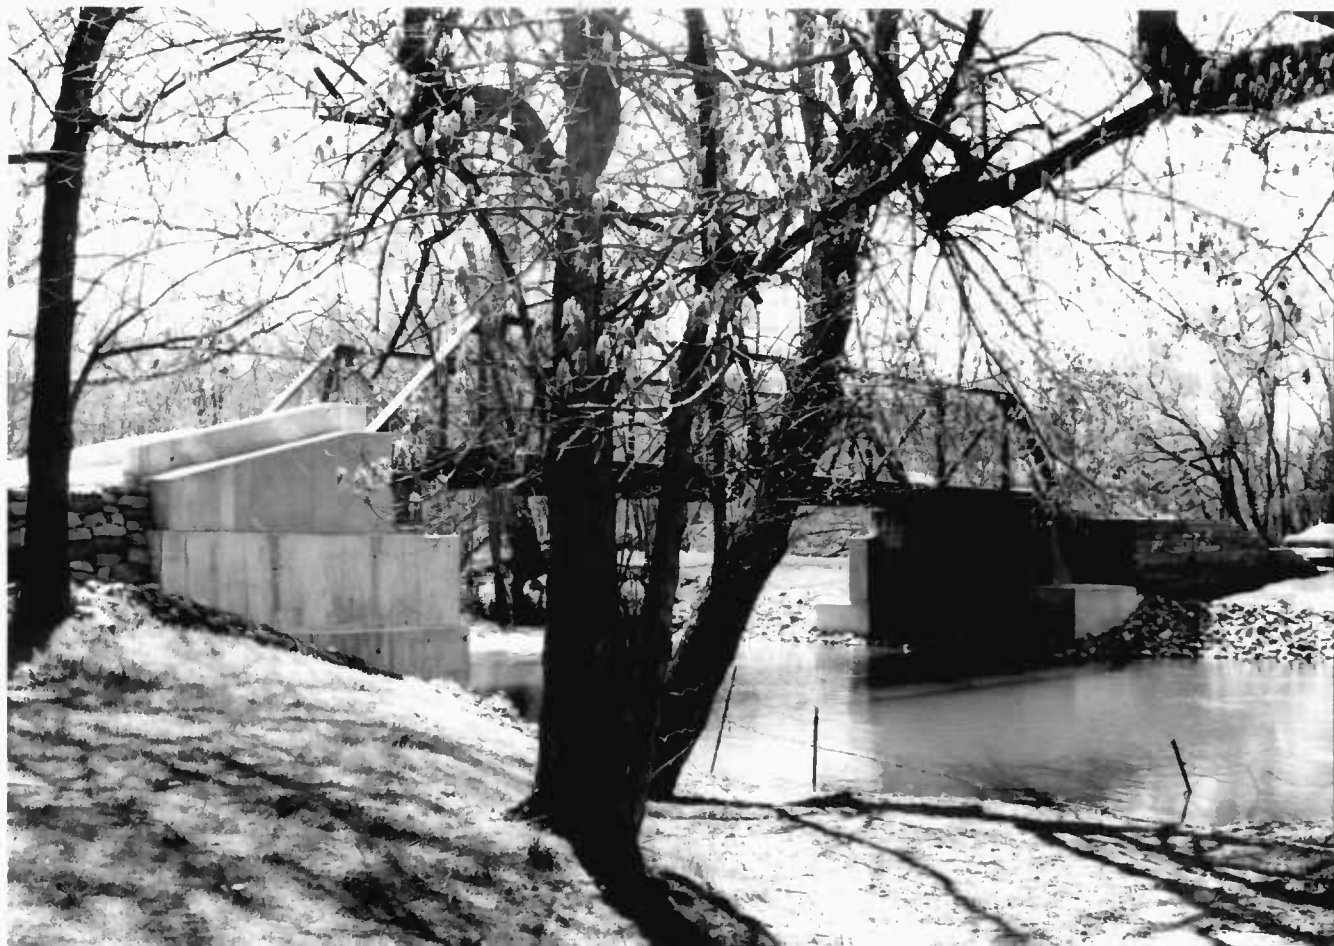
#17 of 13

Bridge

Another twentieth-century feature is a simple iron-truss bridge that carries the driveway over Antietam Creek. The bridge crosses the creek to the southeast of the concrete-block shed. Mrs. Baldoff said the bridge was built in 1956. Recently, she hired a bridge engineer to rebuild the concrete foundations and floor of the bridge.¹⁶
